REPAIRS TO THE TĀJ MAḤAL

By M. S. VATS

Most wartime visitors to the Tāj MaḤal found its dome obscured by scaffolding. The Superintendent in charge of the Northern Circle of the Archaeological Survey of India at Agra here gives the reason.

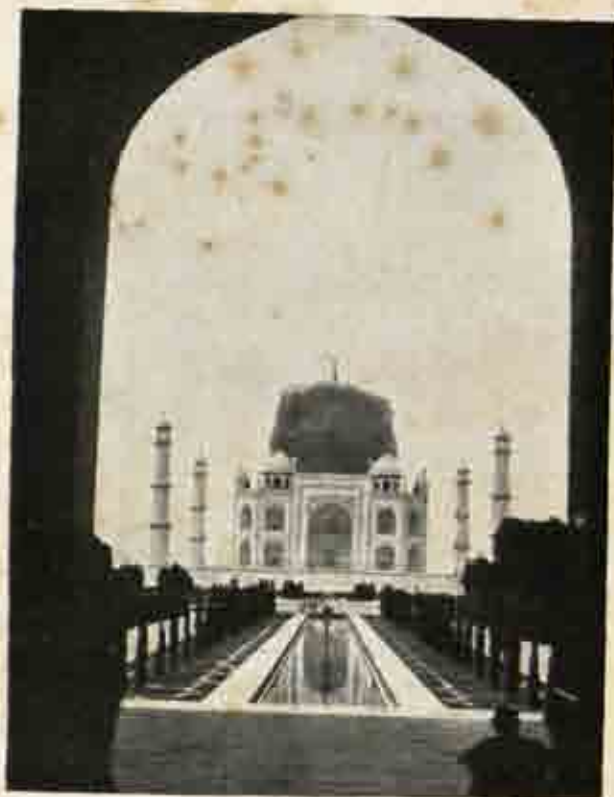
*The Taj Mahal, Agra. Top right, recent view of scaffolding.
Below, flood-lighting by U.S.A. troops on 'VE' Day, 1945.*
