### ON EXCAVATING A HOUSE THAT WAS NEVER BUILT !

By B. B. LAL

# SARDARGARH (RAJASTHAN) 1961

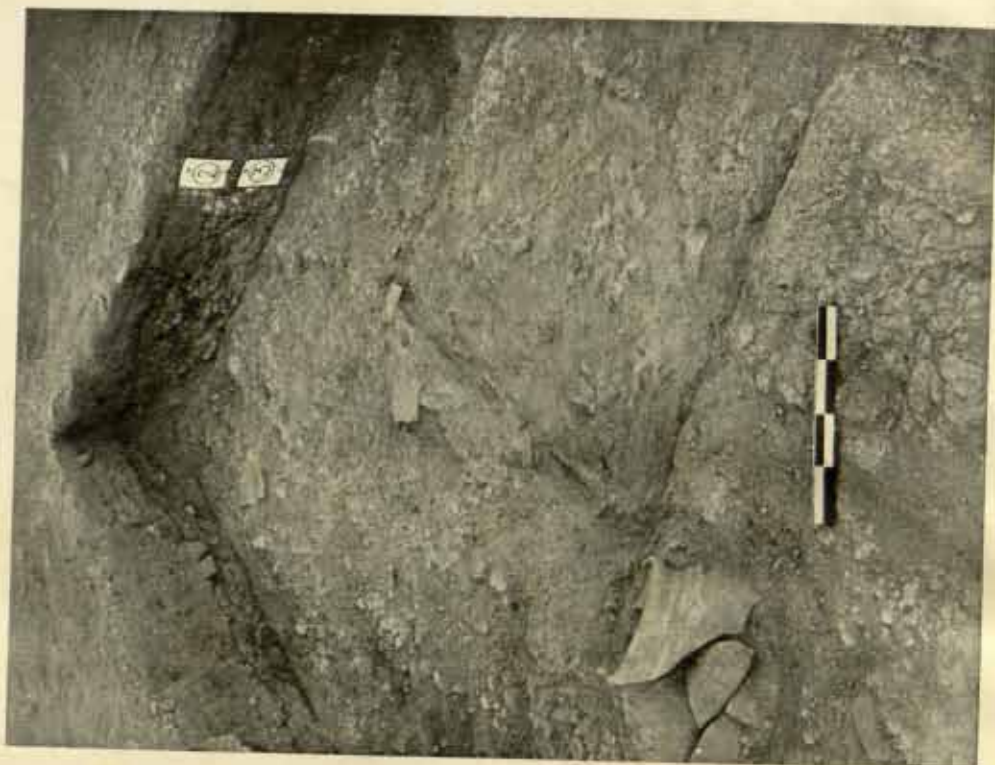
B. Sardargarh: close-up of the square end of the foundation-trench (cf. pl. XLVA and south-eastern quadrant of Square ZB I in fig. 1). Scale: each division 5 cm. See p. 208

The extension of the operations into Square ZB 1 brought to light not merely the fourth corner (though under the baulks in fig. 1 and on pl. XLV A, yet easily inferable on the analogy of the south-eastern corner in Square B 1), but also a 'square' end of the 'channel' (cf. fig. 1, and pls. XLV A and XLVI B). Giving a closer view of this end, pl. XLVI B also shows how, by chance, a pot, occurring in the preceding occupational deposits, just escaped destruction.

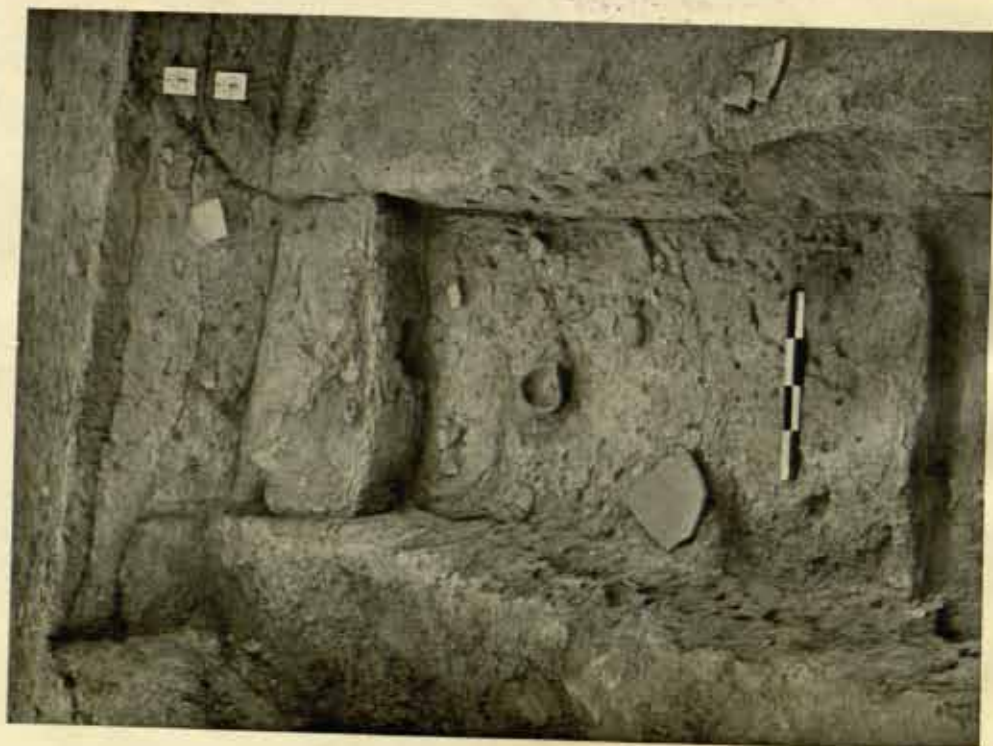
A. Sardargarh: close-up of a section across the foundation trench. At the bottom may be seen Kushan pottery, and above it bands of sand and silt. Scale: each division 5 cm. See p. 208

The excavation threw valuable light also on the probable date of the proposed building of the house. A look at pl. XLVI A would show that the foundation-trench was cut into layer 3 and sealed by layer 2. The former contained the Painted Grey Ware (first-half of the first millennium B.C.), and the latter Kushan pottery (early centuries A.D.). The latter pottery was also recovered from the foundation-trench. The obvious inference, therefore, would be that it was in the Kushan period that somebody wanted to build the house. The foundation-trench was dug, leaving out the space for the entrance on the east. However, as chance would have it, the house was never constructed. In the exposed foundation-trench, therefore, accumulated layers of silt and sand in wet and hot weathers. (There is too much of sand about in the area, and observations show that such

a shallow trench—about  $\frac{1}{3}$ -m. deep—can easily get filled up in a couple of years at the most.) The rains must have brought into the trench a few of the Kushan sherds that had been lying about on the adjoining surface.
