REPAIRS TO THE TĀJ MAḤAL

By M. S. VATS

Most wartime visitors to the Tāj MaḤal found its dome obscured by scaffolding. The Superintendent in charge of the Northern Circle of the Archaeological Survey of India at Agra here gives the reason.

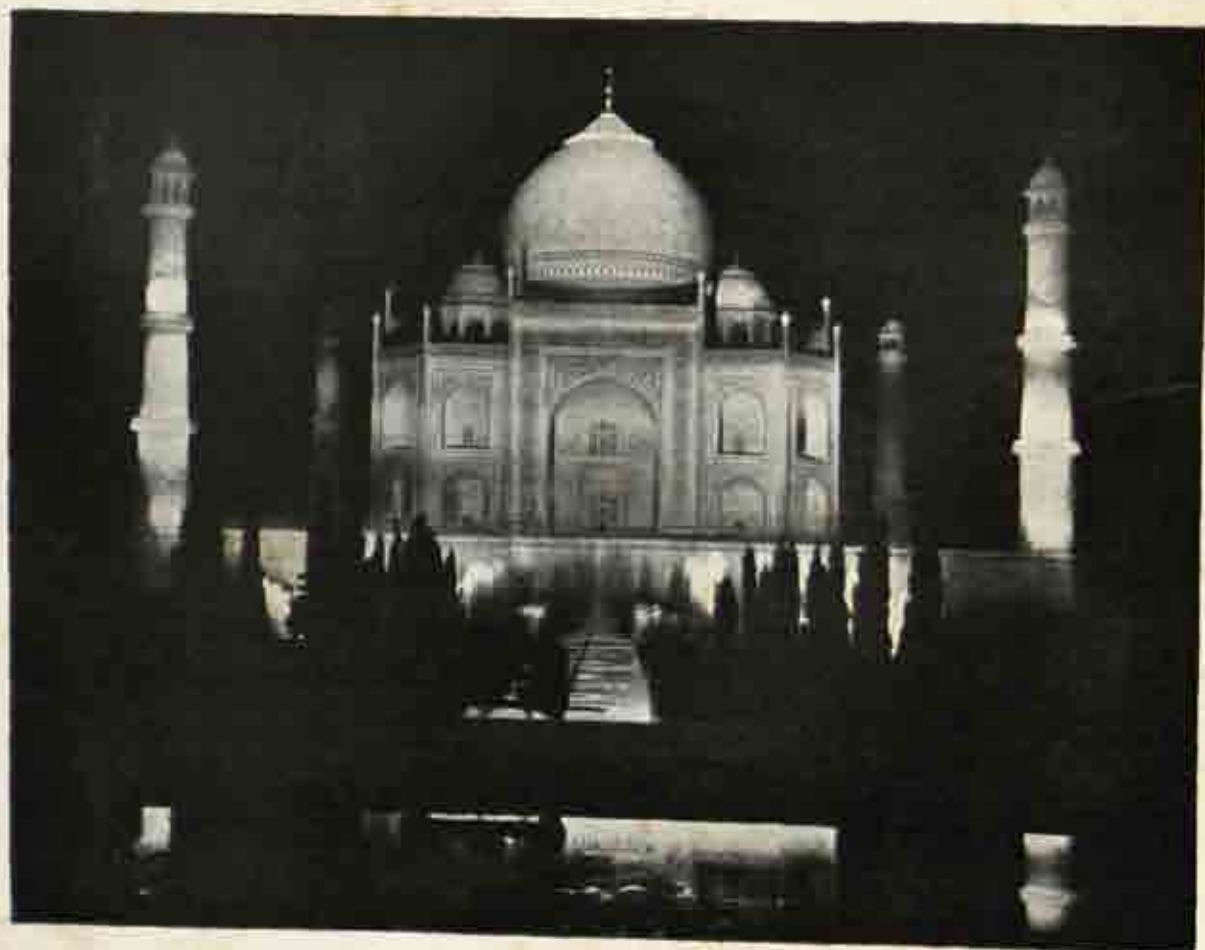
*The Taj Mahal, Agra. Top right, recent view of scaffolding.
Below, flood-lighting by U.S.A. troops on 'VE' Day, 1945.*

(a) Rain-water should be prevented from entering the masonry of the dome and the drum. To make the dome watertight, it is necessary that all the stones that have bulged out or cracked be reset or replaced in 'hydraulic lime mortar' with stones to the full height and thickness of a course. Patchwork should be avoided. The joints should be carefully filled with special lime mortar. This process should be repeated whenever necessary.
